Home Inspection Report

1234 School House Road
Yourtown, US 12345

Prepared for: Bob Smith

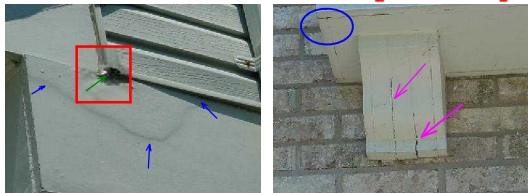
1. The wood window boxes have water damage and will require repair/replacement. The wood has started to separate at the supports and at the corners of the window boxes.

2. The trim board at the southwest corner of the porch has water damage due to water penetration and will require repair/replacement of the wood. The trim board extends out

creating a ledge allowing water to collect on the top edge of the board and cause the wood to rot.

Recommend estimate/repairs by a qualified contractor.
